GreenStar™ 3 2630 Display

Release Notice

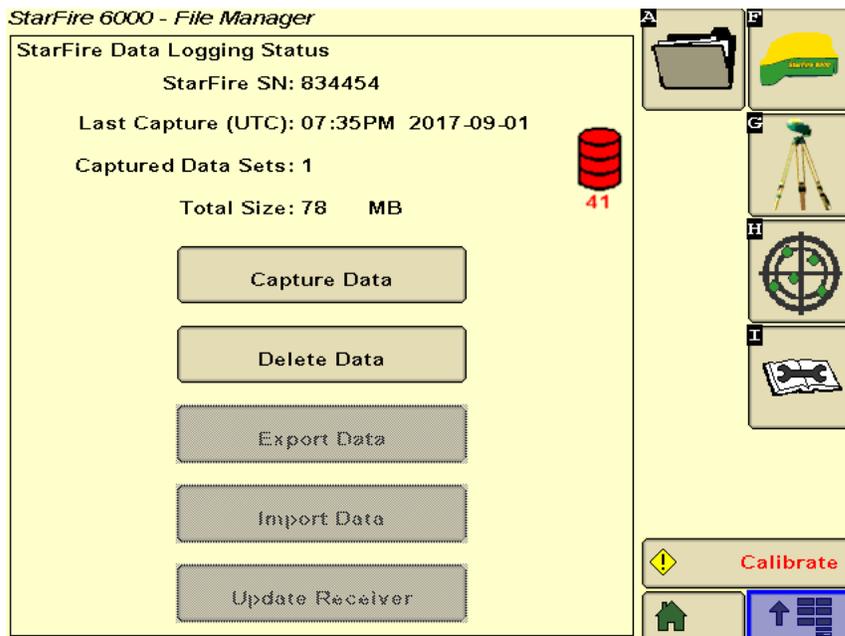
File Manager Defect – A new icon has been implemented to detect an internal hardware failure. After installing 18-1 software, there could be a red icon with the number 41 present, if an internal hardware failure is detected. The receiver will function as normal, but if the “Capture Data” button is pressed, the user will get the error of “Insufficient Storage” and not be able to collect data. The receiver will need to be replaced to have the ability to “Capture Data” and not receive the “Insufficient Storage” error.
